# NeuConnect

## BIJLAGE 9 DETAILED UXO MARINE RISK ASSESSMENT

## Detailed Unexploded Ordnance (UXO) Risk Assessment

<b>Project Name</b>	HVDC Electricity Transmission Interconnector between the Isle of Grain, UK and Wilhelmshaven, Germany
<b>Client</b>	Intertek
<b>Site Address</b>	Kent, England to Lower Saxony, Germany
<b>Report Reference</b>	DA6316-01
<b>Date</b>	10 <sup>th</sup> August 2018
<b>Originator</b>	MN

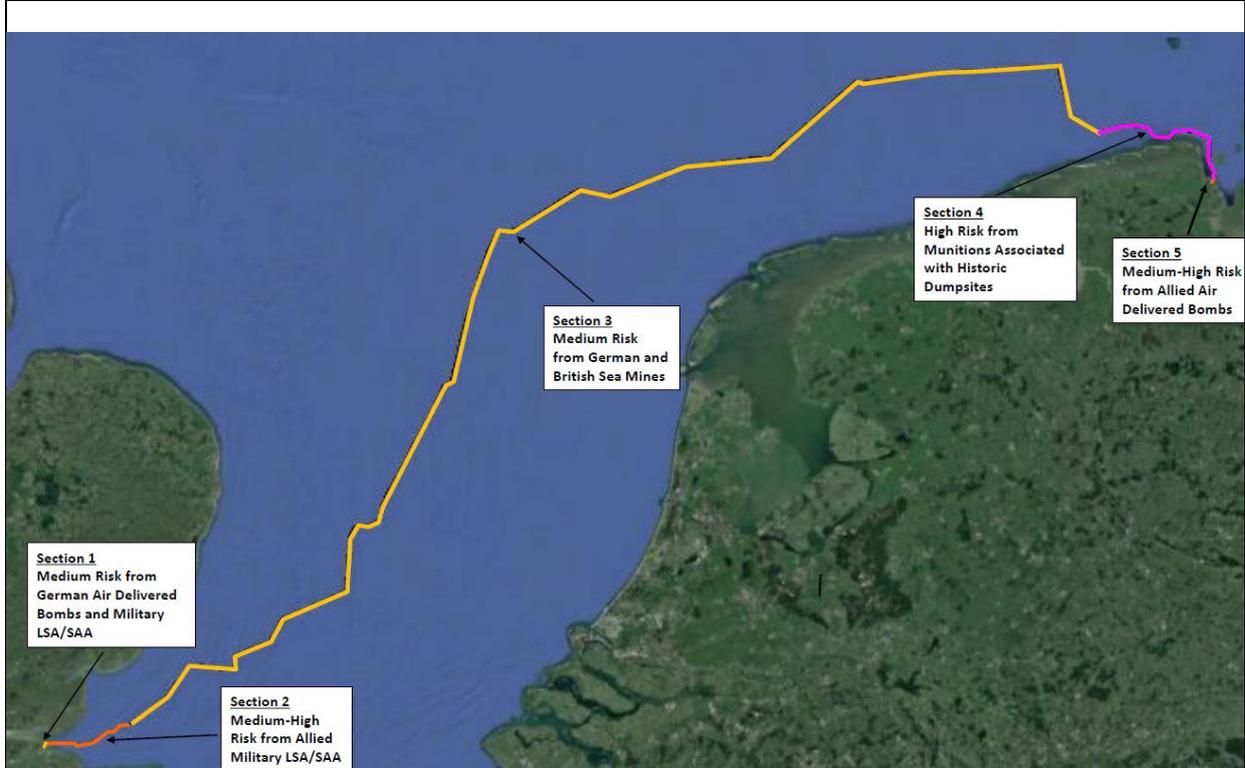
### Risk Map

For indicative purposes – not to scale.

Low Risk    Medium Risk    Medium-High Risk    High Risk

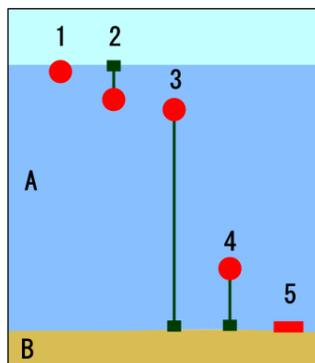
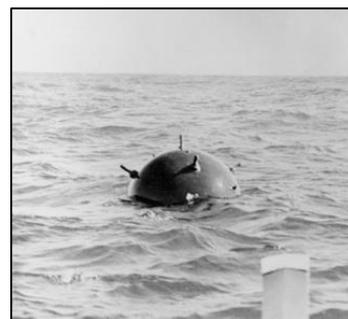
- **Bottom mines** are most effective in shallow waters, such as rivers, harbours and tidal areas. These mines rest on the ground or sea bed and are intended to block passageways and prevent amphibious invasion.
- **Moored mines** are used for deep water areas and are designed to float below the surface of the water. They take into account the tidal level to remain out of site below the waterline and are connected via steel cable to an anchor on the sea bed. These mines are intended to inflict damage to valuable marine craft targets, such as aircraft carriers or battleships.
- **Drifting mines** are allowed to float freely in the water. They were generally utilised less frequently and mostly as a deterrence tactic. Moored mines could break from their anchoring cable and become drifting mines.

Top left: Diagram displaying mine types. A: Underwater, B: Sea bed 1/2: Drifting Mine, 3/4: Moored Mine, 5: Bottom Mine.

Top right: Photograph of drifting mine. Left: Bottom mine.

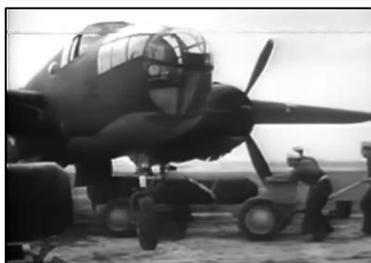
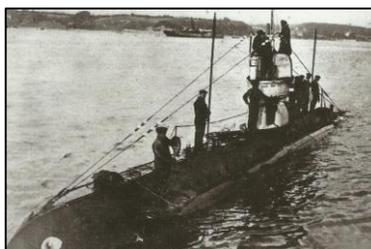
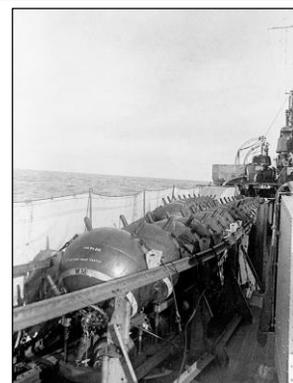
Top right: Horned contact mines on the HMS Aurora .

Top left: Photograph of mine loading onto US aircraft. Bottom left: Mine-laying submarine UC-1, which could carry a total of 12 mines.

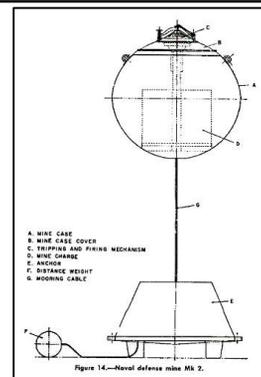
Schematics of Navy Spherical Mine Mk 2.

Name	Type of laying	Diameter	Explosive charge	Notes
Navy Spherical Mine Marks I and II	Moored	Unknown	250 lbs. (113 kg)	British mine using an automatic anchor and an arm-operated firing mechanism. only 4,000 available by the start of World War I.
"Type I" (British designation)	Moored	31.5 in. (80 cm)	180 lbs. (81.6 kg)	WWI-era German "Hertz horn" contact mine.
"Type II" (British designation)	Moored	31.5 in. (80 cm)	290 lbs. (131 kg)	Same as above.
Type H Mark II	Moored	Unknown	320 lbs. (145 kg)	First reliable British "Hertz horn" contact mine, available from 1917 and used in early years of WWII.
EMA	Moored	31.5 in. (80 cm)	331 lbs. (150 kg)	First German mine with a chemical-horn firing system.
UMA	Unknown	31.5 in. (80 cm)	66 lbs. (30 kg)	German mine with five Hertz and three switch horns. Could be moored at either 160 or 320 feet (50 or 100 m).

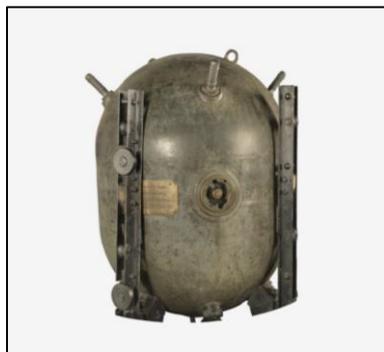
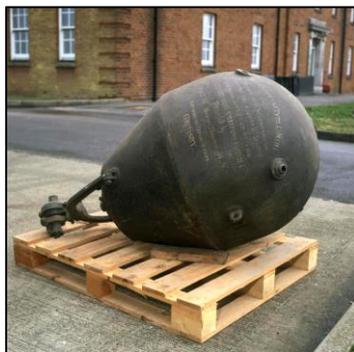
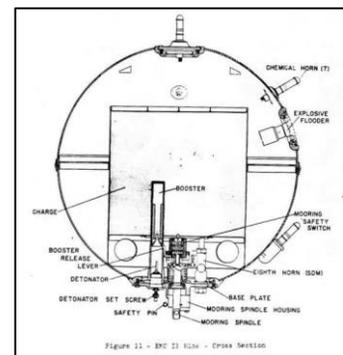
Figure 33 - SRC 23 7/24 - OPIKA SWEDEN

Left: found July 1917 in Thames Estuary. Centre: found December 1914 in water off Scarborough, identified as "Type I" mine. Right: Schematics of moored contact mine with "Hertz horn" mechanics.

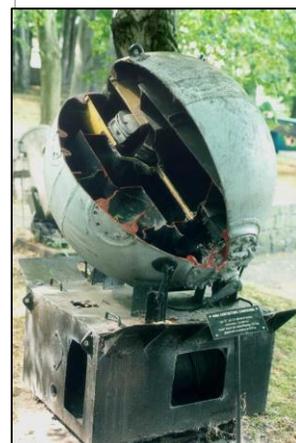
An SMA Mine.

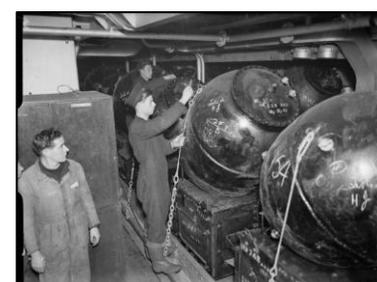
Left: Schematic of an LMA early pattern airborne parachute ground influence mine. Right: Mines aboard HMS Apollo ca 1945, likely to be M Mark I mines.

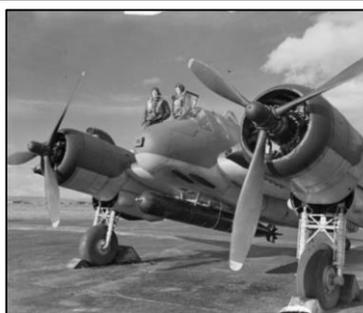
Left: A Mark XII torpedo fitted to a Bristol Beaufighter. Top right: Model of the torpedo. Bottom left: schematics.

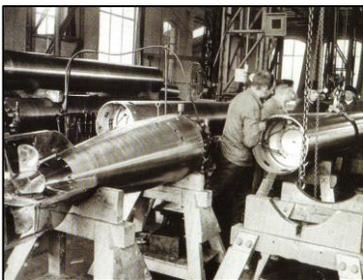
Deployed by	Surface ships and submarines
Date of design/service	1930/1938
Weight	3,369 lbs. (1,528 kg)
Overall length	23 ft. 7 in. (7.186 m)
Explosive charge	617 lbs. (280 kg) Hexanite
Range / speed	6,560 yards (6,000 m) / 44 knots 8,750 yards (8,000 m) / 40 knots 15,000 yards (14,000 m) / 30 knots
Remarks	Issued throughout WWII and considered to be very reliable.

Left: G7a Torpedoes being repaired at Ostende in 1940. Top right: Model of the torpedo. Bottom right: Schematics.

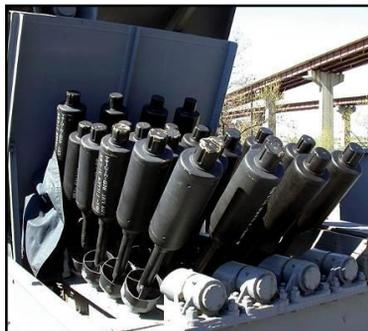
Weight	29 kg
Explosive Weight	14 kg
Dimensions	118 cm long, 17.8 cm diameter
Fuze Type	Contact fuze
Use	Fired from a launcher on the attacking ship, these projectiles were fired in an arc and were designed to land in an elliptical pattern in the water to hit enemy submarines.
Remarks	This weapon was invented in order to address the issue of "instantaneous echo" when an enemy submarine was so close to the attacking ship that it could not be accurately plotted by a sonar operator and was effectively invisible.

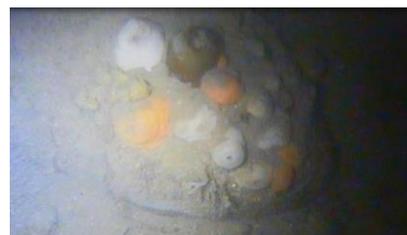
Preparations are under way to remove three unexploded bombs found on the sea bed at a wind farm site off the north Wales coast.

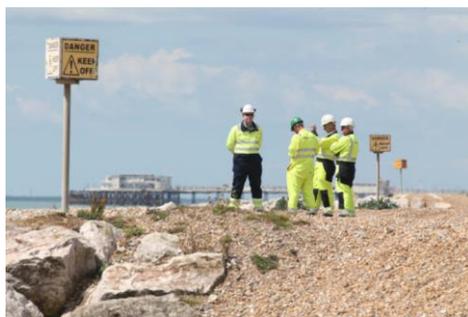
Two unexploded WW2 devices will be detonated in a controlled explosion this week as works continue on the Rampion offshore wind farm.

Thought to date from the Second World War, the devices are located on the seabed, 3km off Lancing Beach at a depth of 13m.

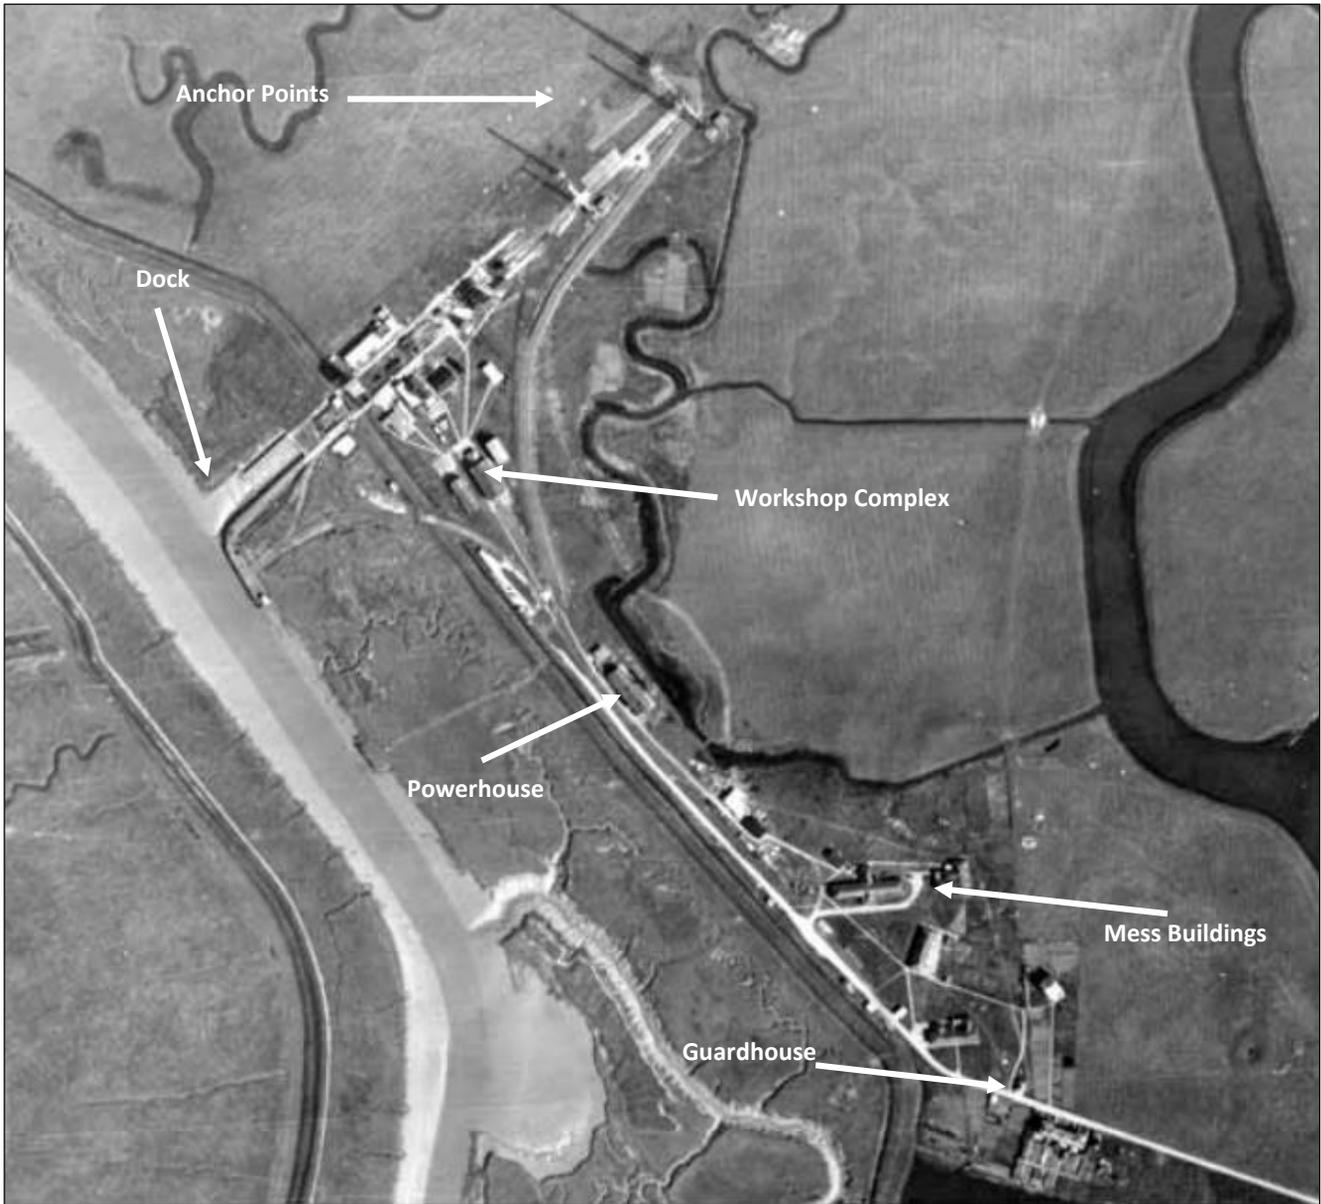
1946 aerial imagery of the Yantlet firing point main complex, situated approximately 1.5km west of the western endpoint of the study area. Railway firing points (and the rail tracks leading up to them), gun emplacements and gantry paths can all be identified surrounding this image.

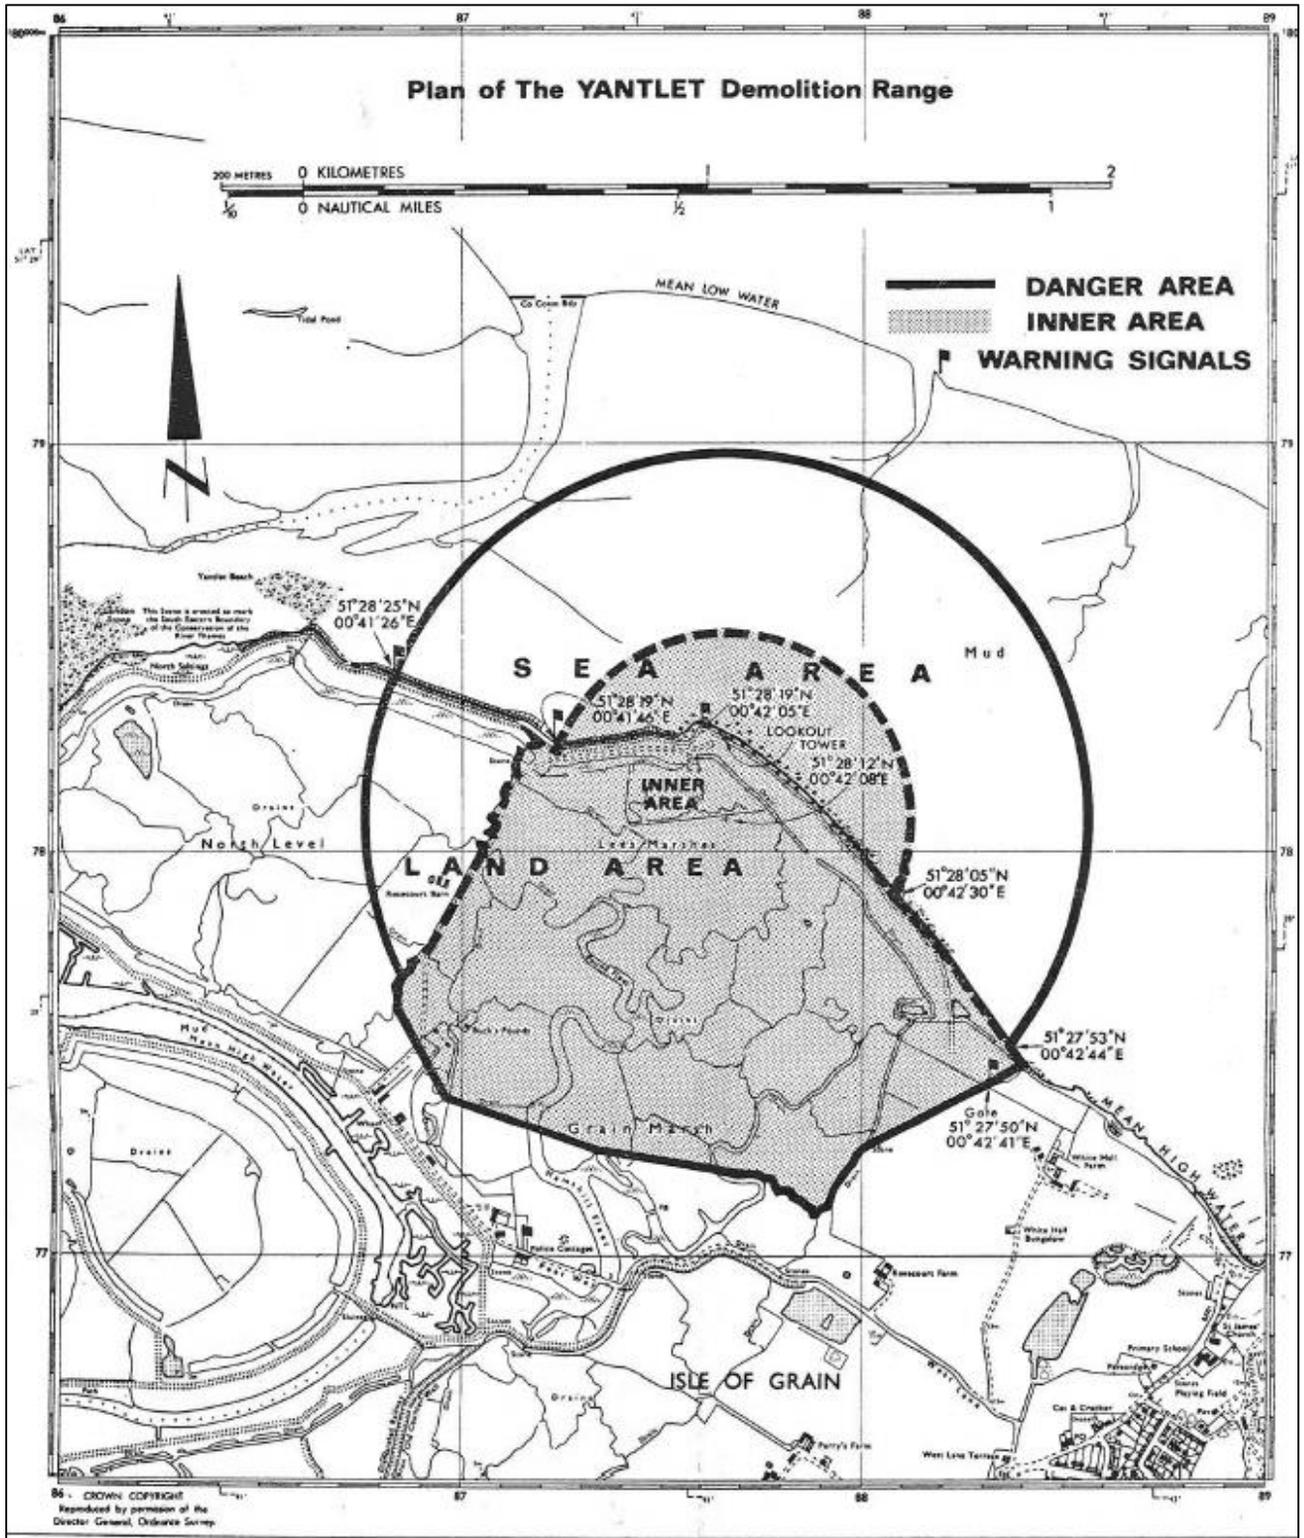
Post-war mapping showing the inner and outer danger areas of Yantlet Demolition Range.

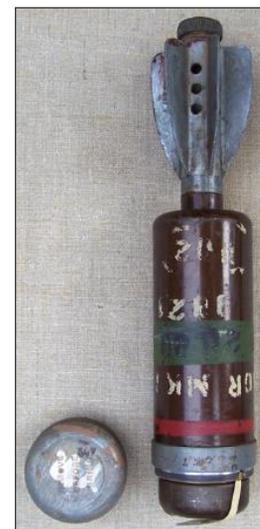
2 inch Mortar Smoke	
Weight	910g (2lb)
Maximum Range	460m (500yards)
Filling	White phosphorus and smoke fill
Dimensions	51 x 290mm (2in x 11.4 in )
Fuze Type	An impact fuze which initiates a bursting charge. This ruptures the mortar bomb's body and disperses the phosphorus filler
Identification	Smoke mortars have a recess and emission holes. May still see light green body paint. Look for stained ground around munition.
Use	As a screening devices for unit movement or to impair enemy field of vision.

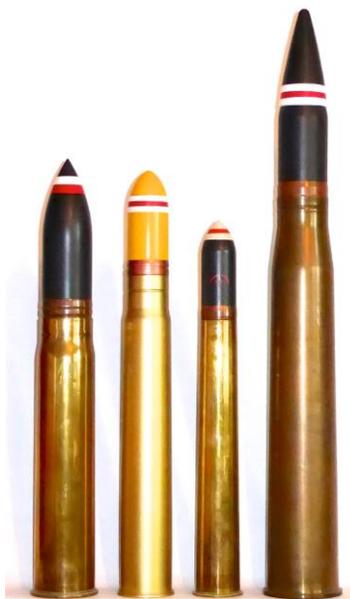
## Examples of Projectiles

From left to right: a 6 pounder 8 cwt; 3 pdr 2 cwt; 2 pdr No. 2; 6 pdr 7 cwt.

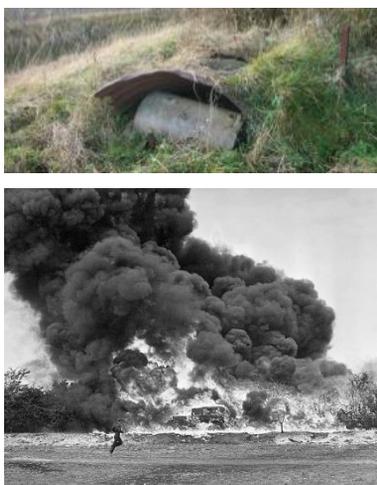
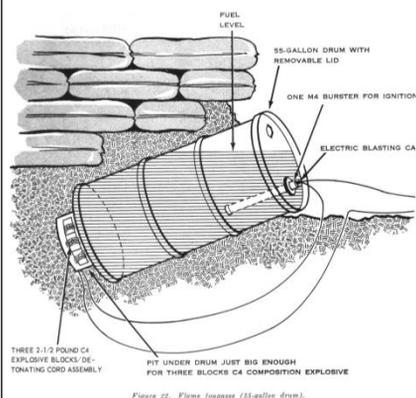
Figure 22. Flame fougasse (55-gallon drum).

Weight	Various
Filling	Initially a mixture of 40% petrol and 60% gas. Ammonal provided the propellant charge.
Design	Usually constructed from a 40-gallon drum dug into a roadside and camouflaged.
Use	As an improvised anti-tank bomb. When triggered the Fougasse could project a beam of burning sticky fuel in a fixed direction from up to 3m (10ft) wide and 27m (30yards) long.
Remarks	A highly unorthodox weapon designed by the Petroleum Warfare Department to address a critical lack of weapons in 1940. 50,000 are estimated to have been distributed around the UK.

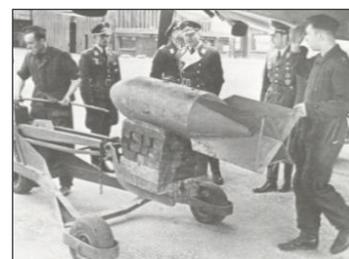
Bomb Weight	245-256kg (540-564lb)
Explosive Weight	125-130kg (276-287lb)
Fuze Type	Electrical impact/mechanical time delay fuze.
Bomb Dimensions	1640 x 512mm (64.57 x 20.16in)
Body Diameter	368mm (14.5in)
Use	Against railway installations, embankments, flyovers, underpasses, large buildings and below-ground installations.
Remarks	It could be carried by almost all German bomber aircraft, and was used to notable effect by the Junkers Ju-87 Stuka (Sturzkampfflugzeug or dive-bomber).

SC250 bomb being loaded onto German bomber

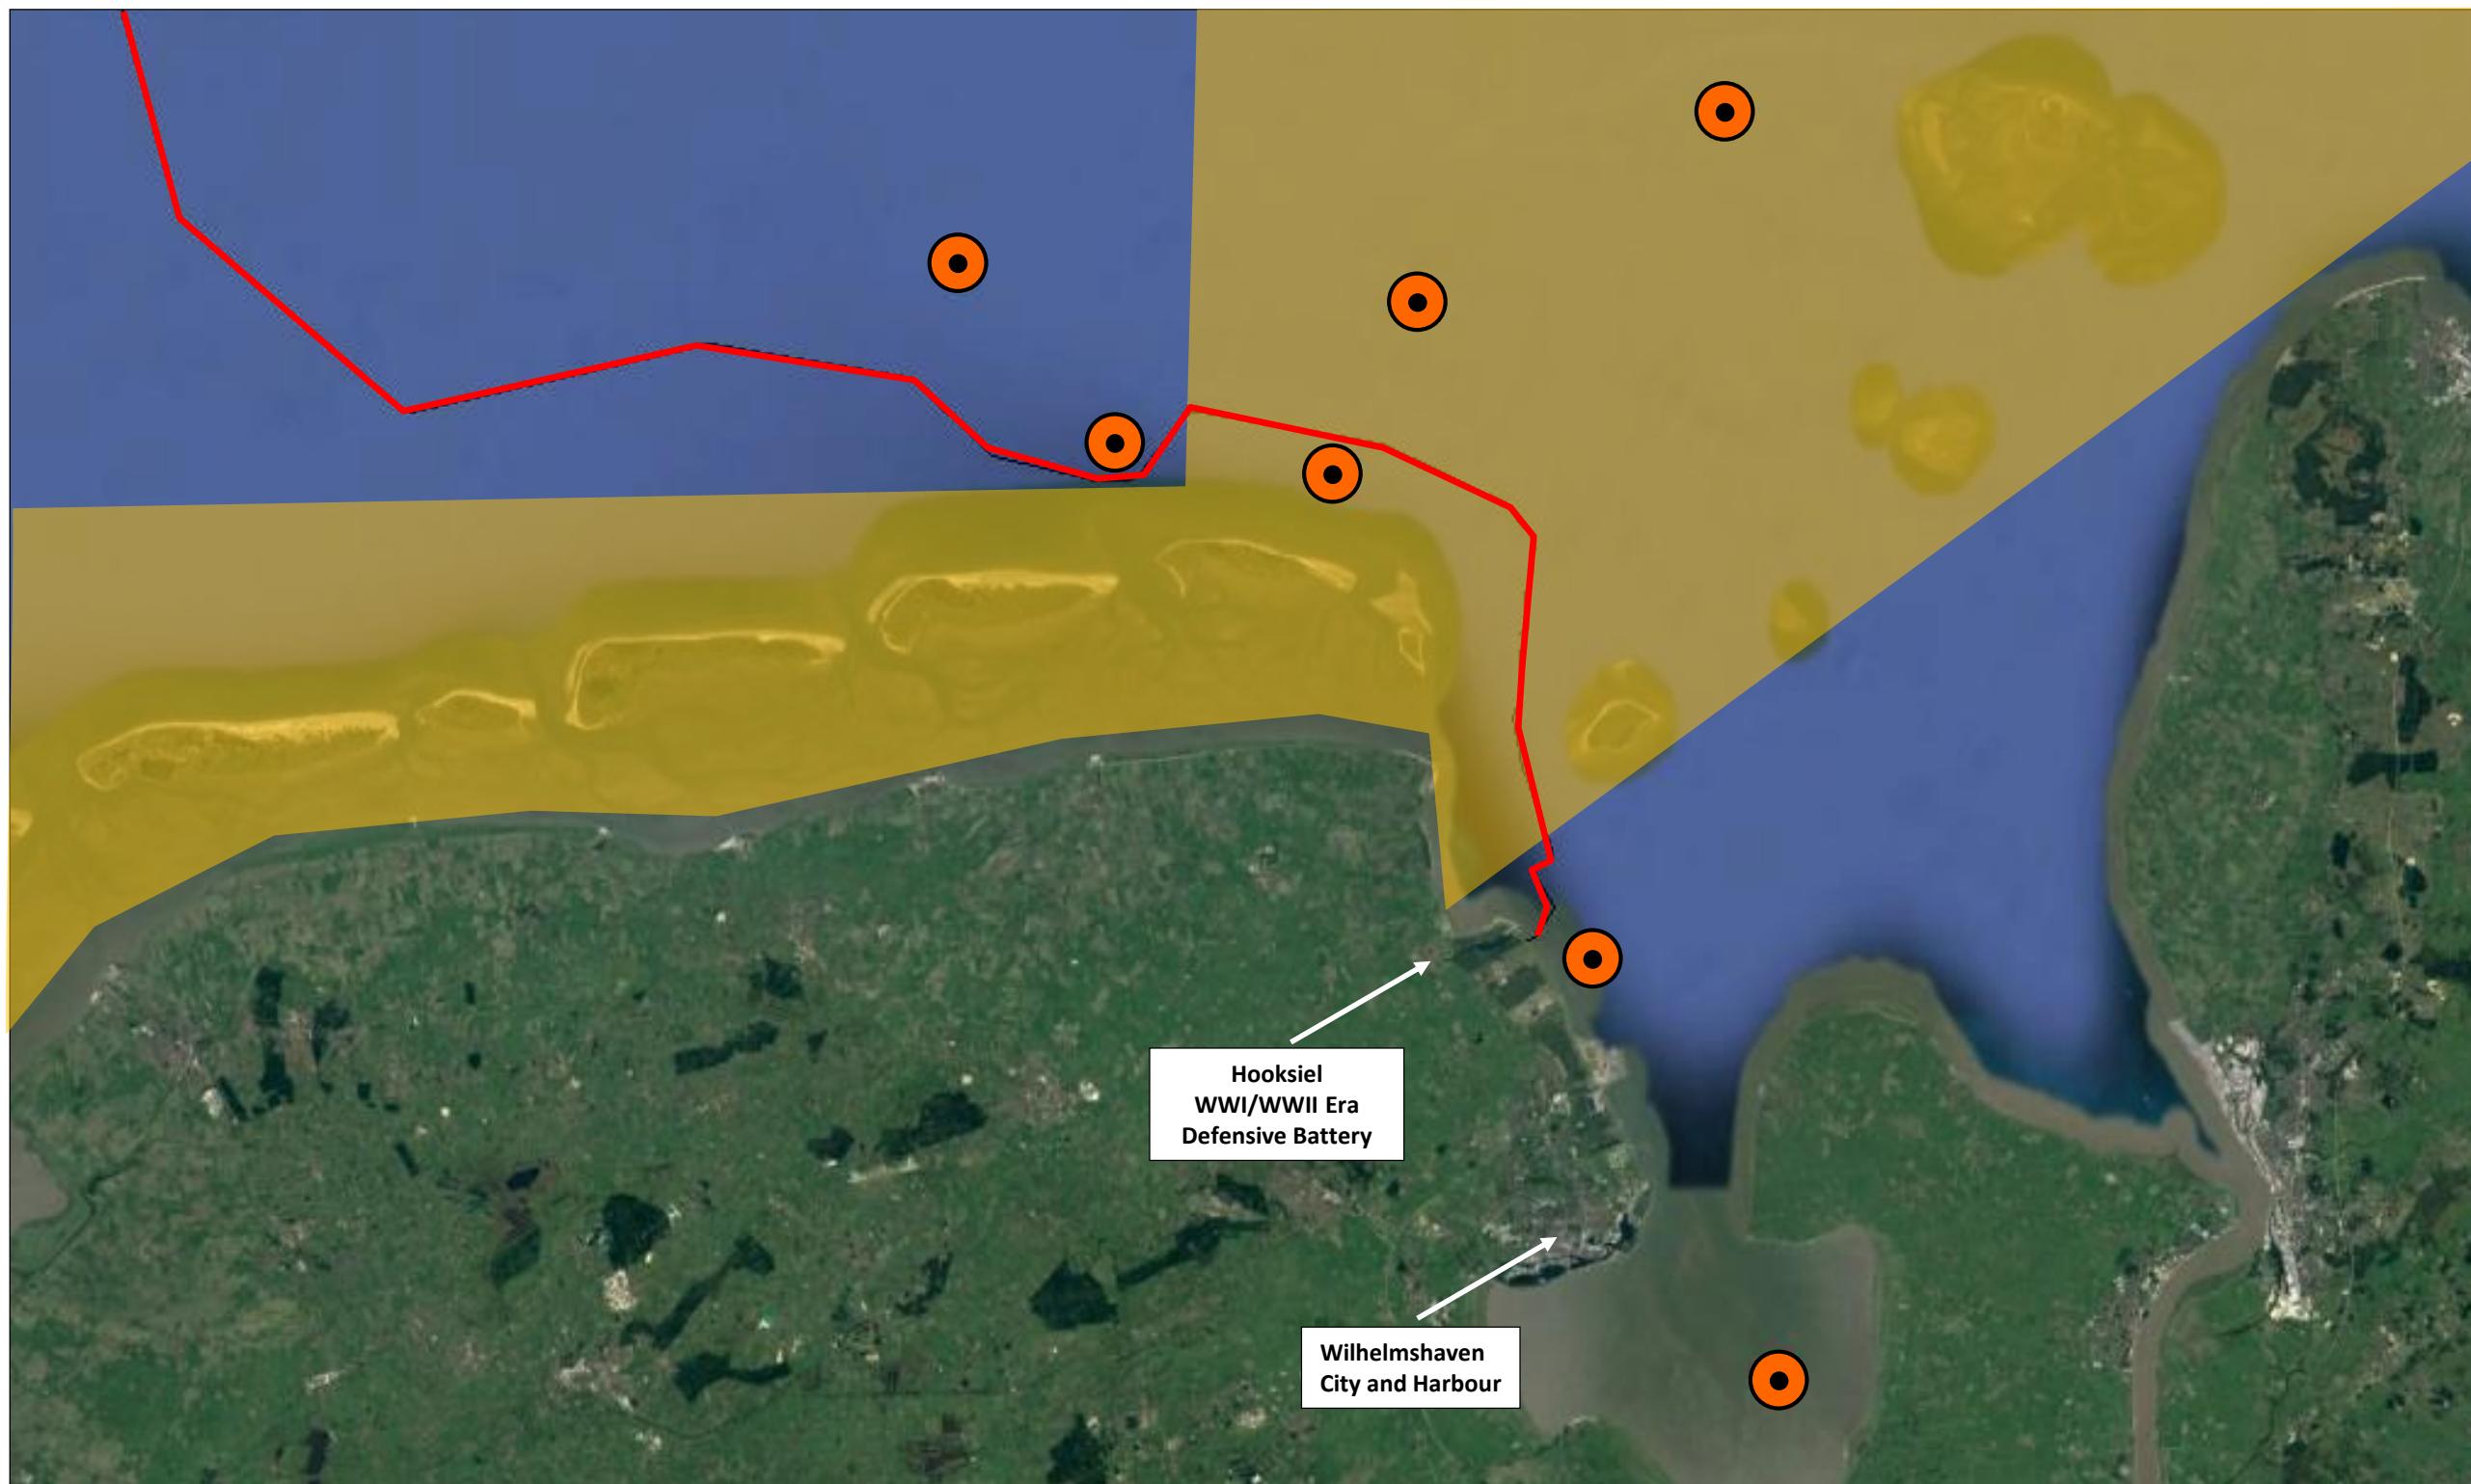
WWII-British Mine Area
  Conventional Munitions Dumpsites

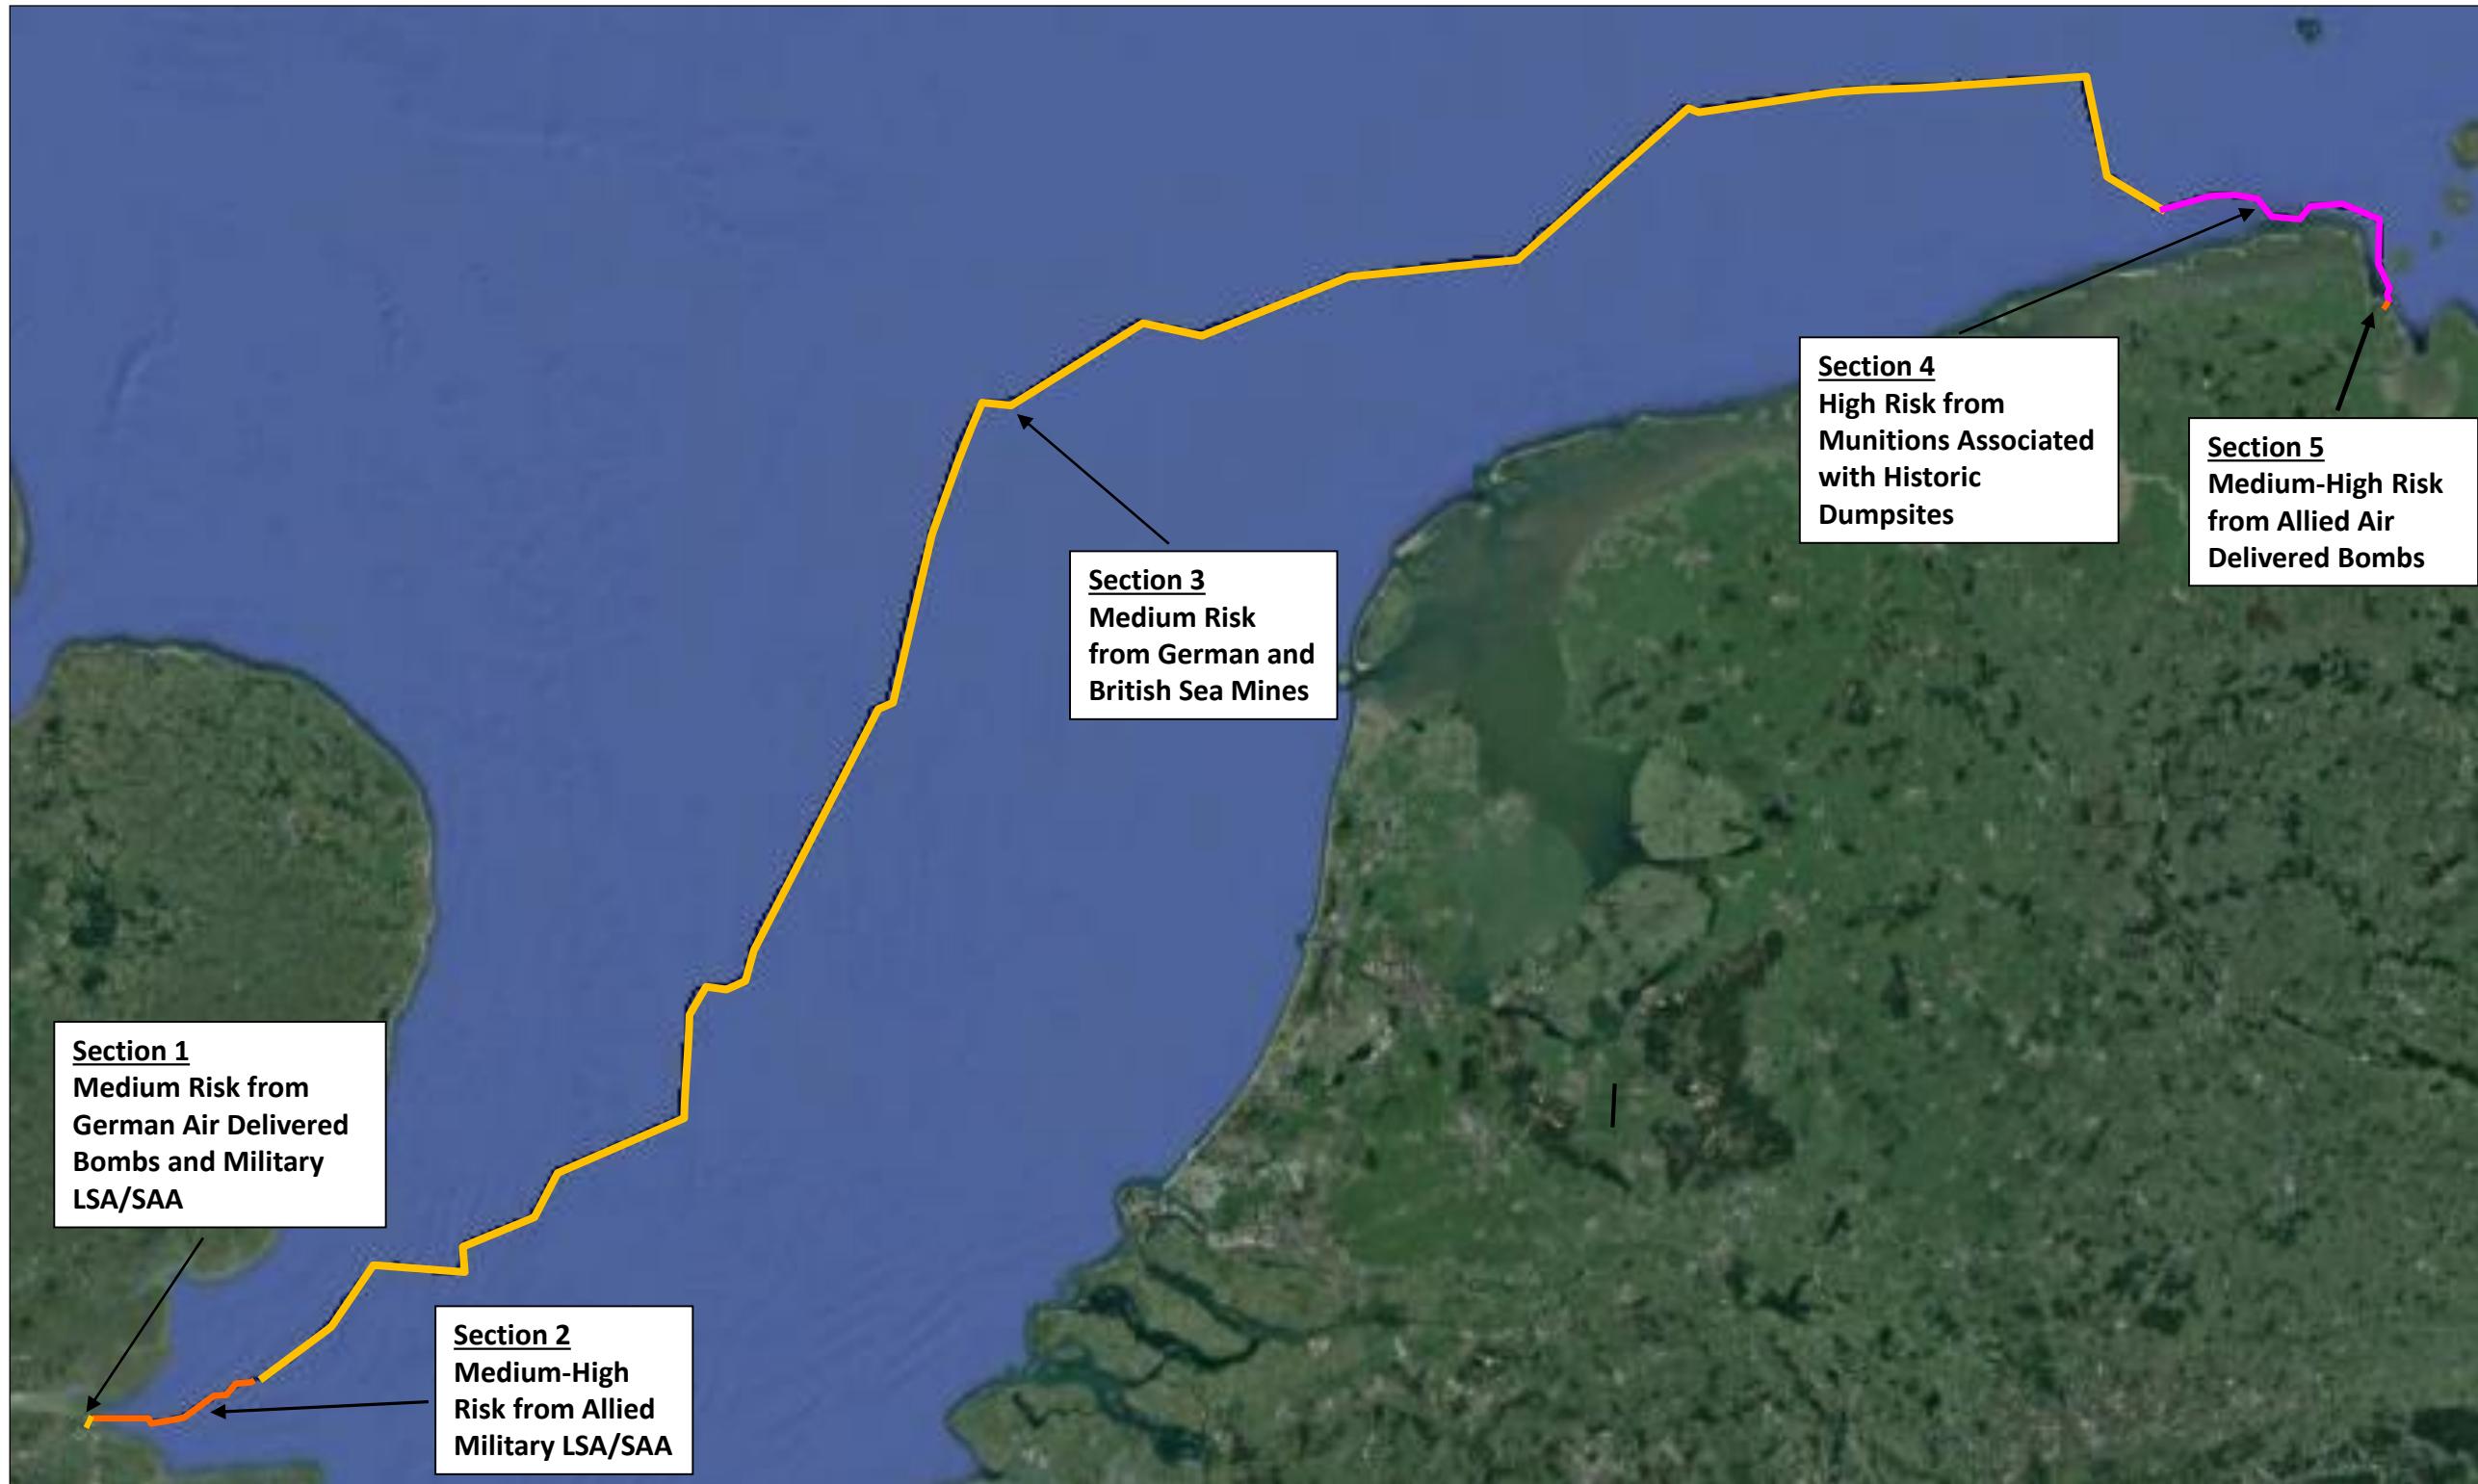
**Section 1**  
 Medium Risk from German Air Delivered Bombs and Military LSA/SAA
