ENVIRONMENTAL CONTAMINATION SURVEY FINAL REPORT

HAMRIYAH POWER PLANT PROJECT	70150

**GEOTECHNICAL SITE INVESTIGATION FOR
PROPOSED SEWA HAMRIYAH POWER PLANT
HAMRIYAH AREA, SHARJAH – U.A.E.**

Report No.	SD18000031
Revision No.	Rev.00
Status	Final Report
Date	15 th July 2018

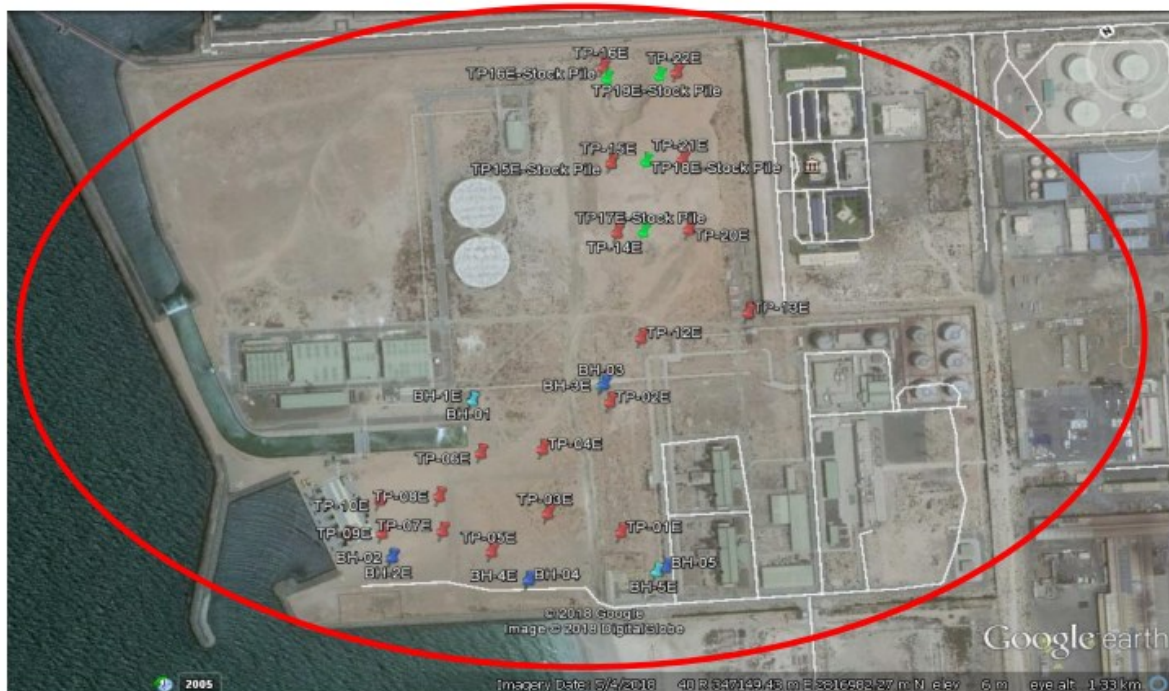
The environmental site investigations have been developed according to the following sampling plan:

Note: The trial-pits and boreholes positions are approximate. The coordinates are presented below.

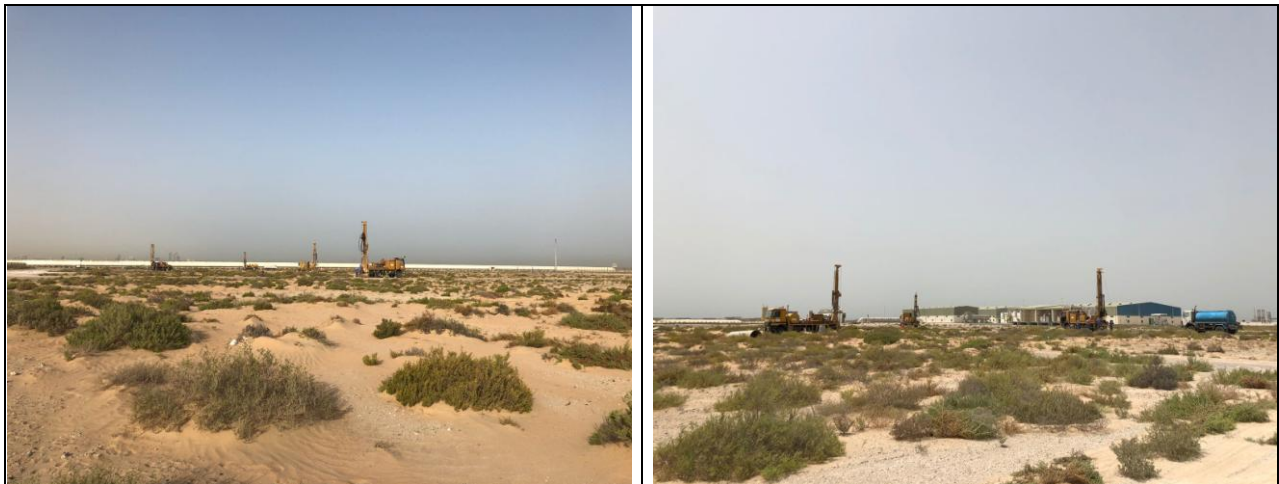
Figure 2: Typical Site Photographs

At the time of investigation the site was uneven and was easily accessible. Ground levels are related to Sharjah Halcrow Municipality Datum (SHMD) & co-ordinates to WGS-84. General site layout plan is presented below:

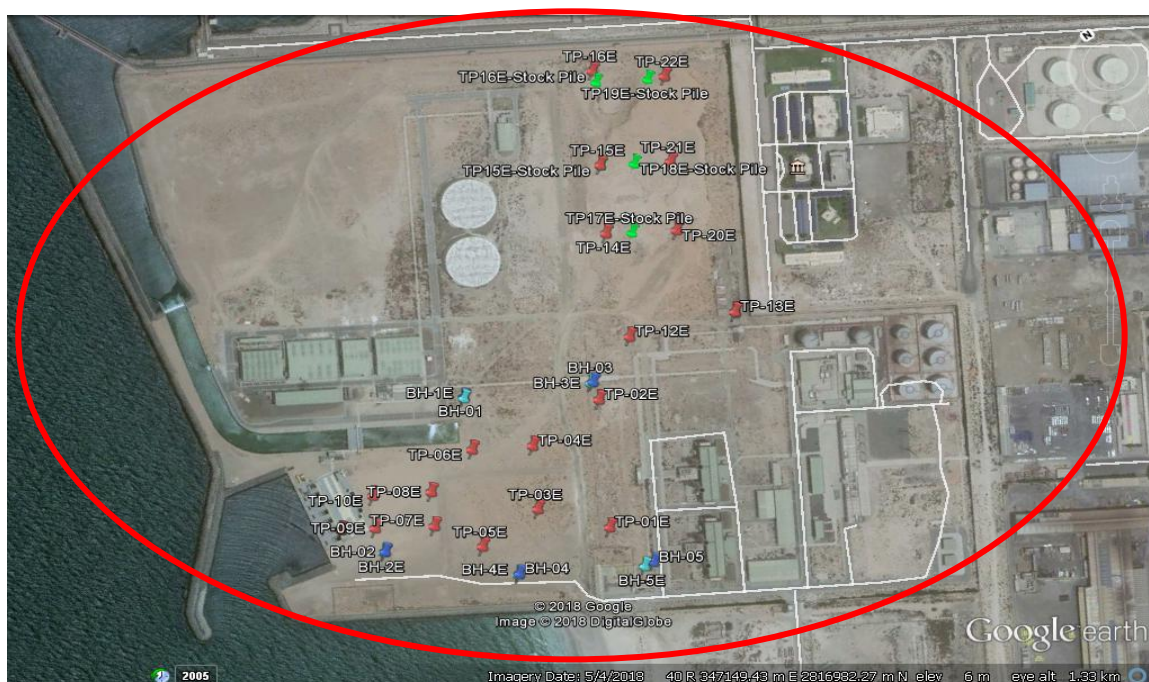
Figure 3: Google Image showing field test locations

A general site plan showing the project layout and all the test locations is presented in **Appendix A**, A Google Image showing the environmental test locations is presented in the figure below.

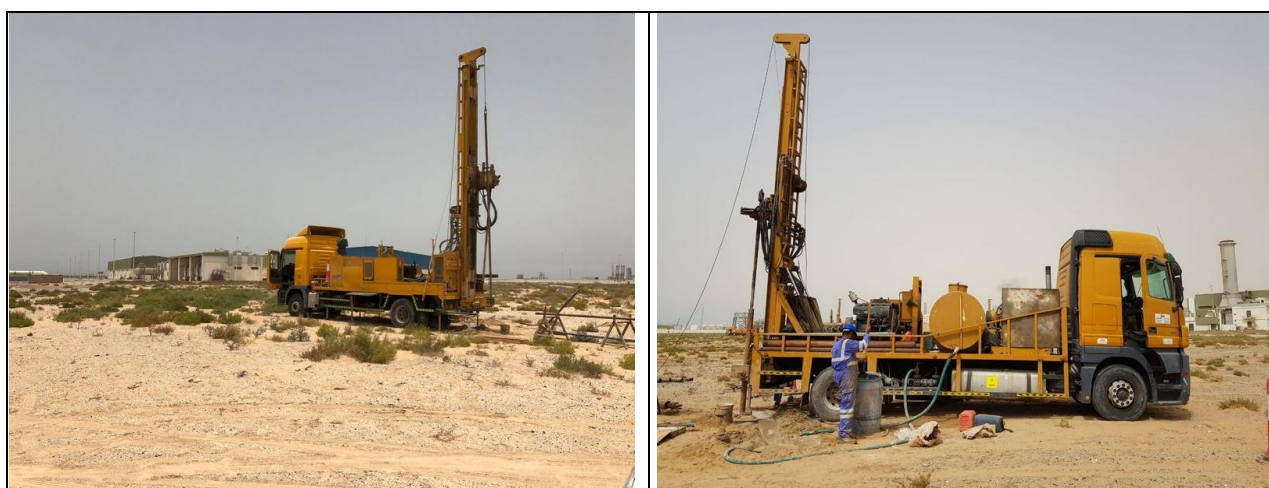
Figure 4: General photograph during drilling of boreholes

General photograph during drilling of boreholes were taken as presented below:

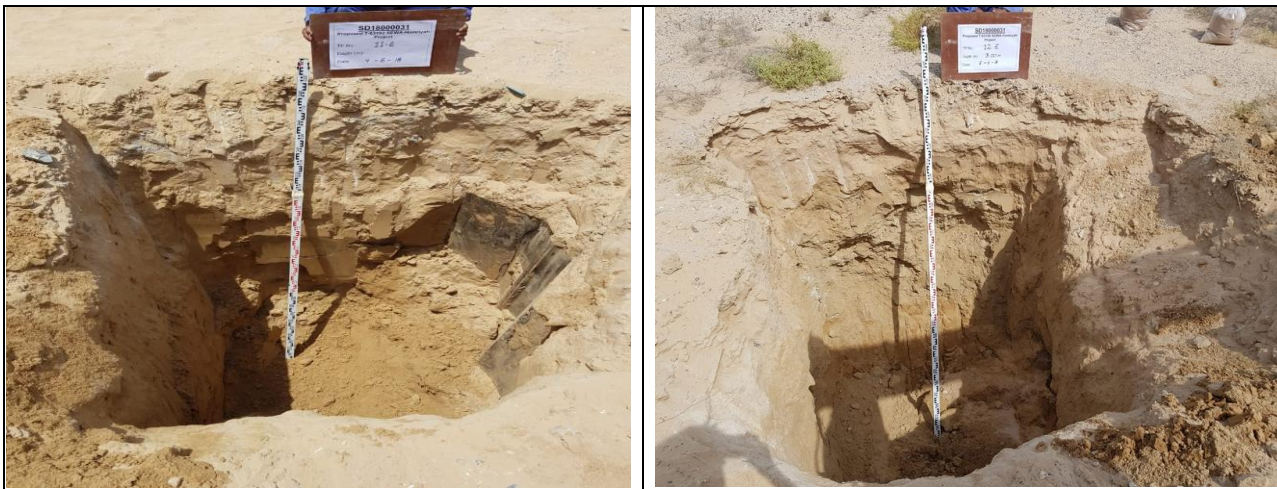
Figure 6: Typical Photographs during Trial Pit Excavation

Excavated materials are placed away from the side of the trial pit at a distance equivalent to the trial pit depth to reduce the risk of the trial pit collapsing.

General Photographs during trial pit excavation are also presented below:
